Pool Systems USA, Inc
Water-Wand Cartridge Cleaner
Technical Bulletin

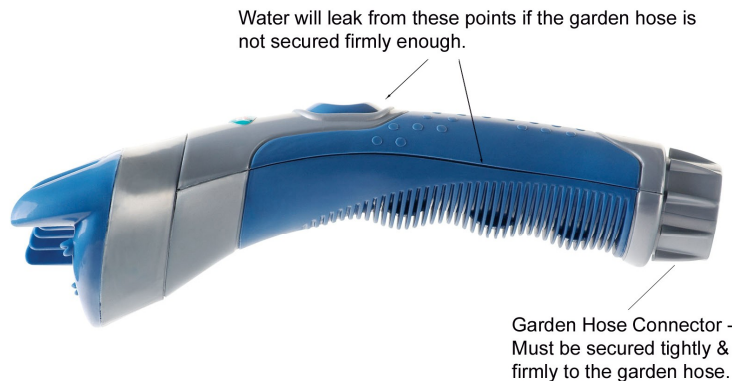
Water-Wand
pool and spa cartridge filter cleaner

If the garden hose is not firmly secured to the product's garden hose connector, water will leak into the housing and out the various seams and openings. This problem is simply resolved by tightening up the garden hose connection.

Many garden hoses and their associated fittings vary in style. If you are having difficulty as a result of this, the use of an additional hose washer may help provide a perfect seal.
